FINAL REPORT  
RICHARDSON FLATS TAILINGS  
SUMMIT COUNTY, UTAH  
TDD #T08-9204-015  
PAN EUT0039SBA

U.S. Environmental Protection Agency  
Region VIII  
Waste Management Division  
Mike Zimmerman, On-Scene Coordinator

Scott Keen  
Ecology and Environment, Inc.  
Technical Assistance Team

**DATE SUBMITTED:** October 23, 1992

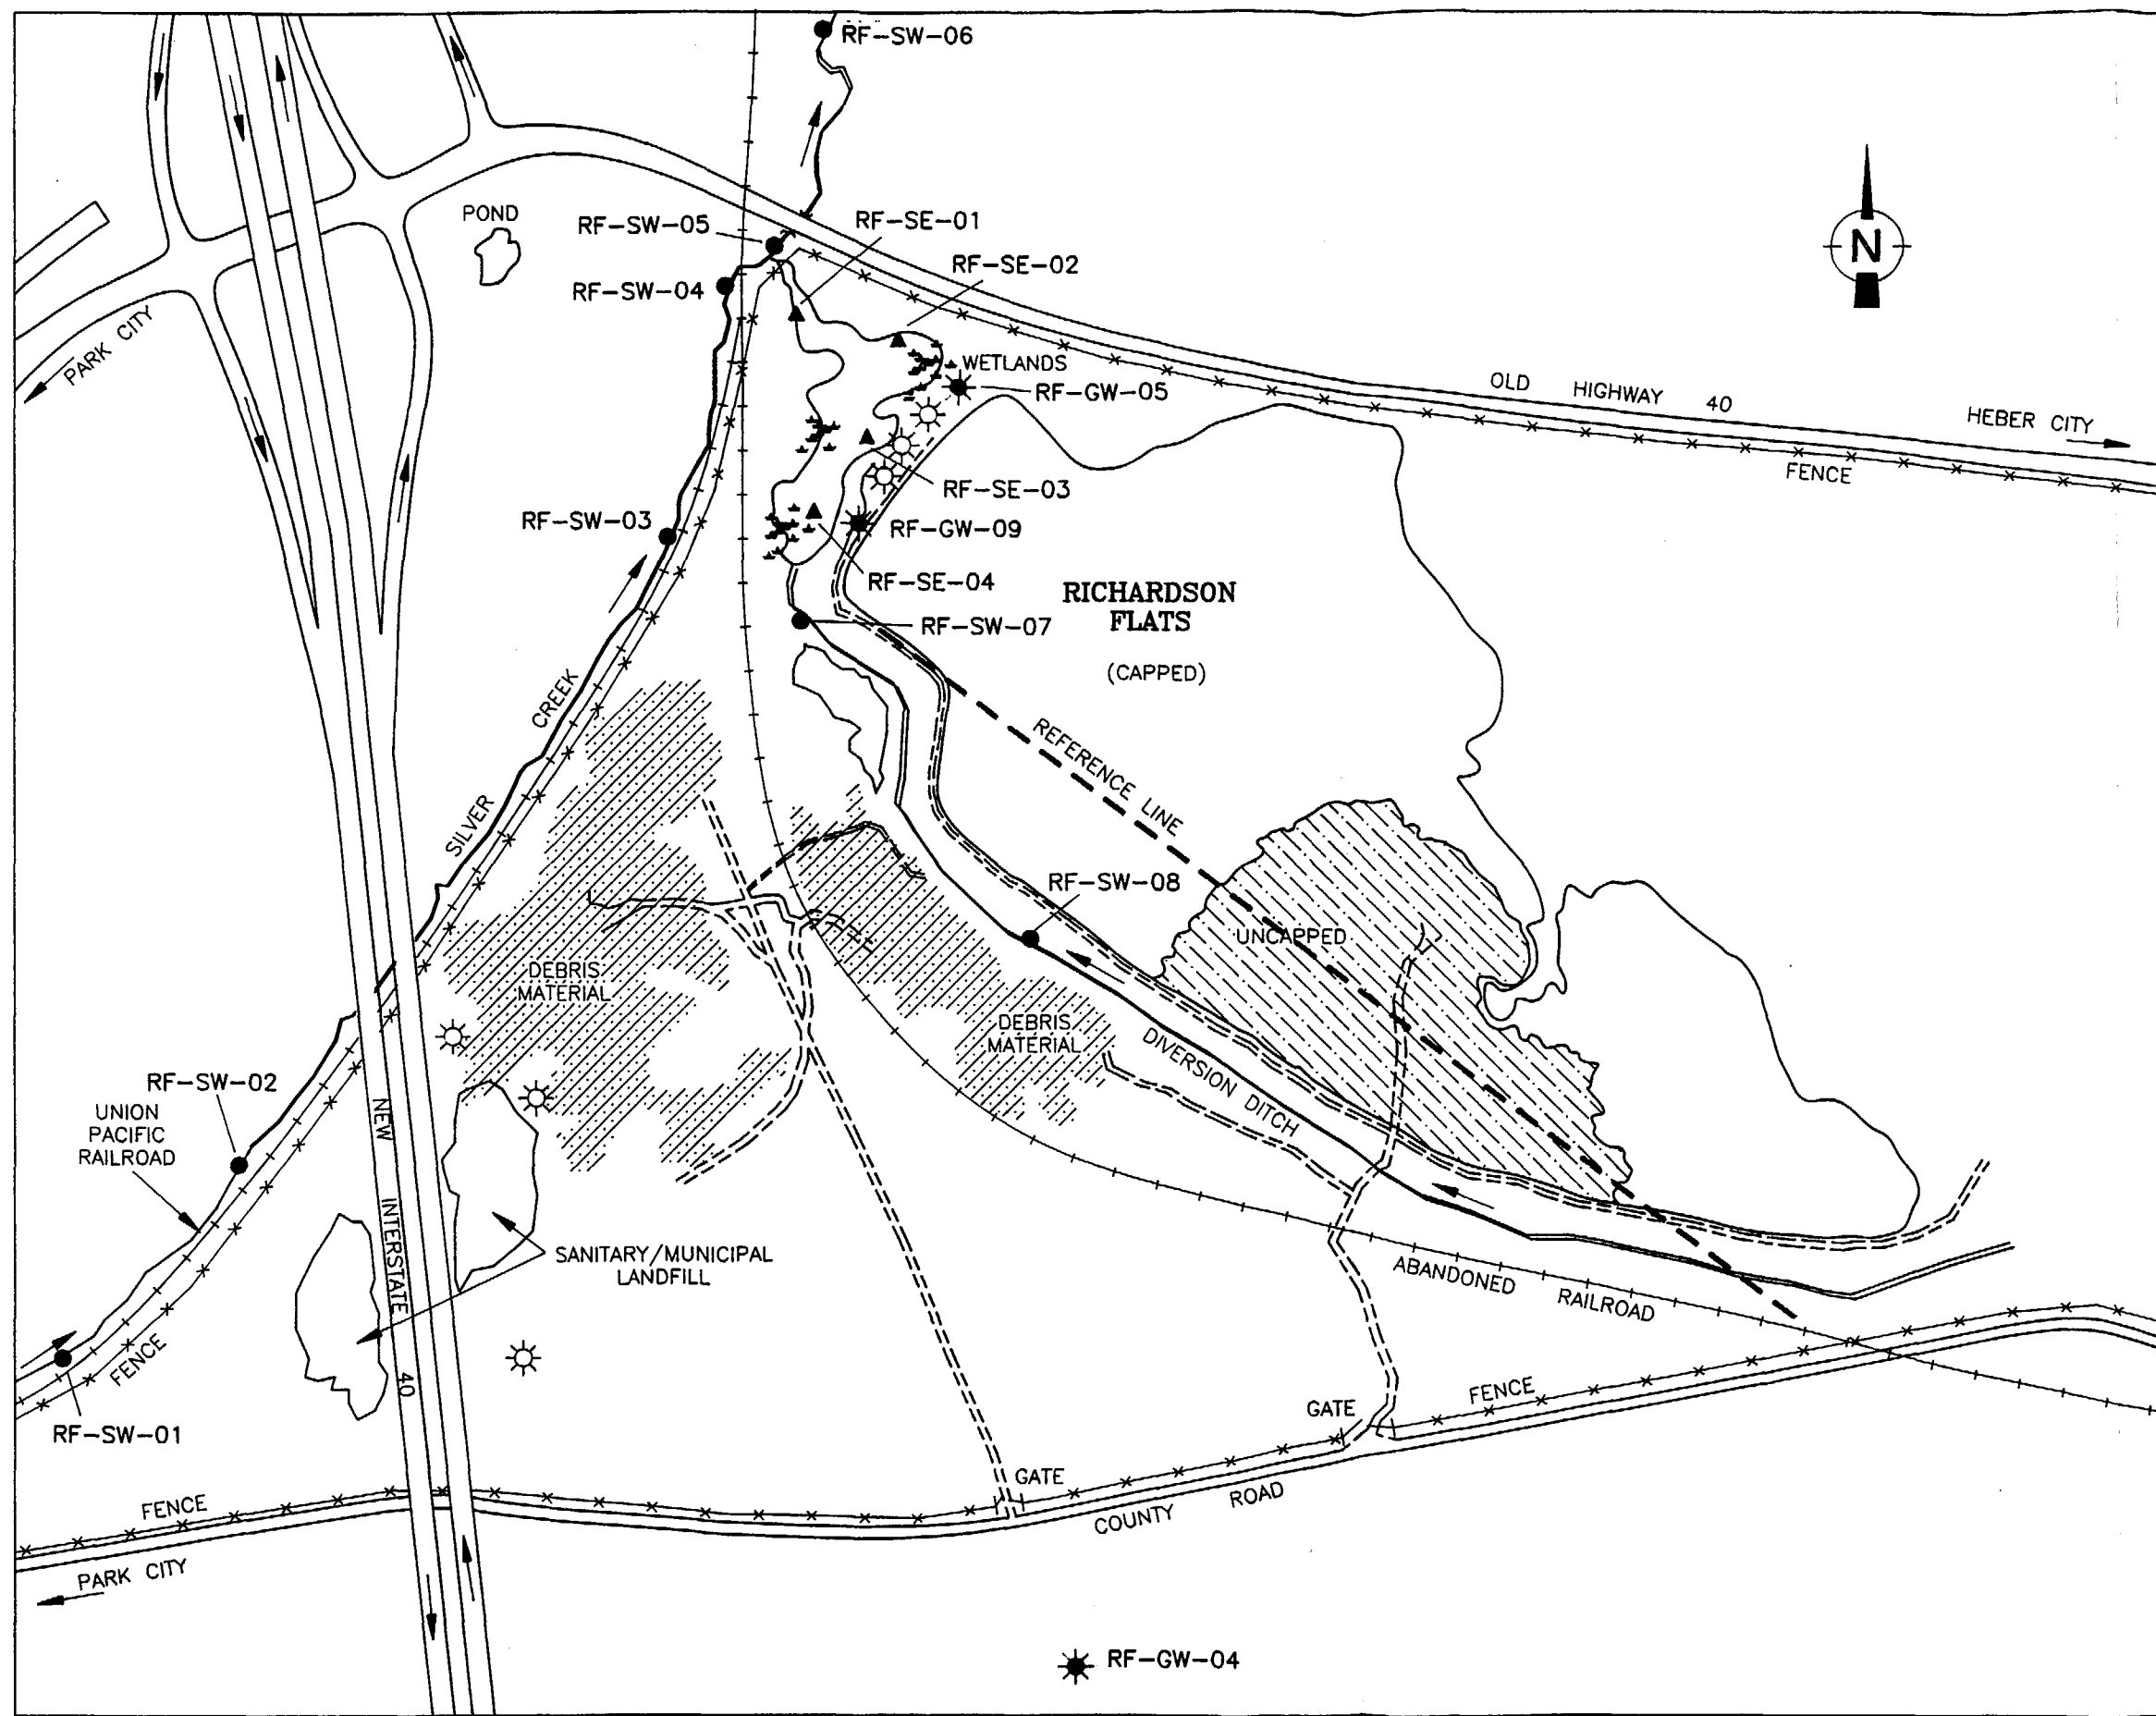
FIG. 1

Surface water samples collected for assessment of the tailings area are shown on Figure 1. These eight sample numbers are RF-SW-01 through RF-SW-08. Inorganic analytical results for surface water samples are presented in Table 3. Within Silver Creek samples RF-SW-01 through RF-SW-04 are considered upgradient of the tailings area and samples RF-SW-05 and RF-SW-06 are downgradient. In comparing upgradient sample results with downgradient sample results very few significant differences are noted. Lead increases by a factor of 5.7 in sample RF-SW-05 when compared to the average lead concentration of the four upgradient samples. In sample RF-SW-06 arsenic increases by a factor of 2.1 and silver increases by a factor of 4.2 when compared to the average concentration of the four upgradient samples.

One upgradient and two downgradient monitoring wells (Figure 1) were sampled during the week of August 4, 1992. Results of inorganic analyses are presented in Table 6. Sample RF-GW-04 is from the upgradient well; samples RF-GW-05 and RF-GW-09 are from two wells at the base of the tailings dam.

Figure 1 shows a "wetlands" area between the base of the tailings dam and Silver Creek. Within this area four sediment samples were collected. Results of inorganic analyses of these samples is presented in Table 7 along with the normal ranges of elemental concentrations in soils of the western United States.

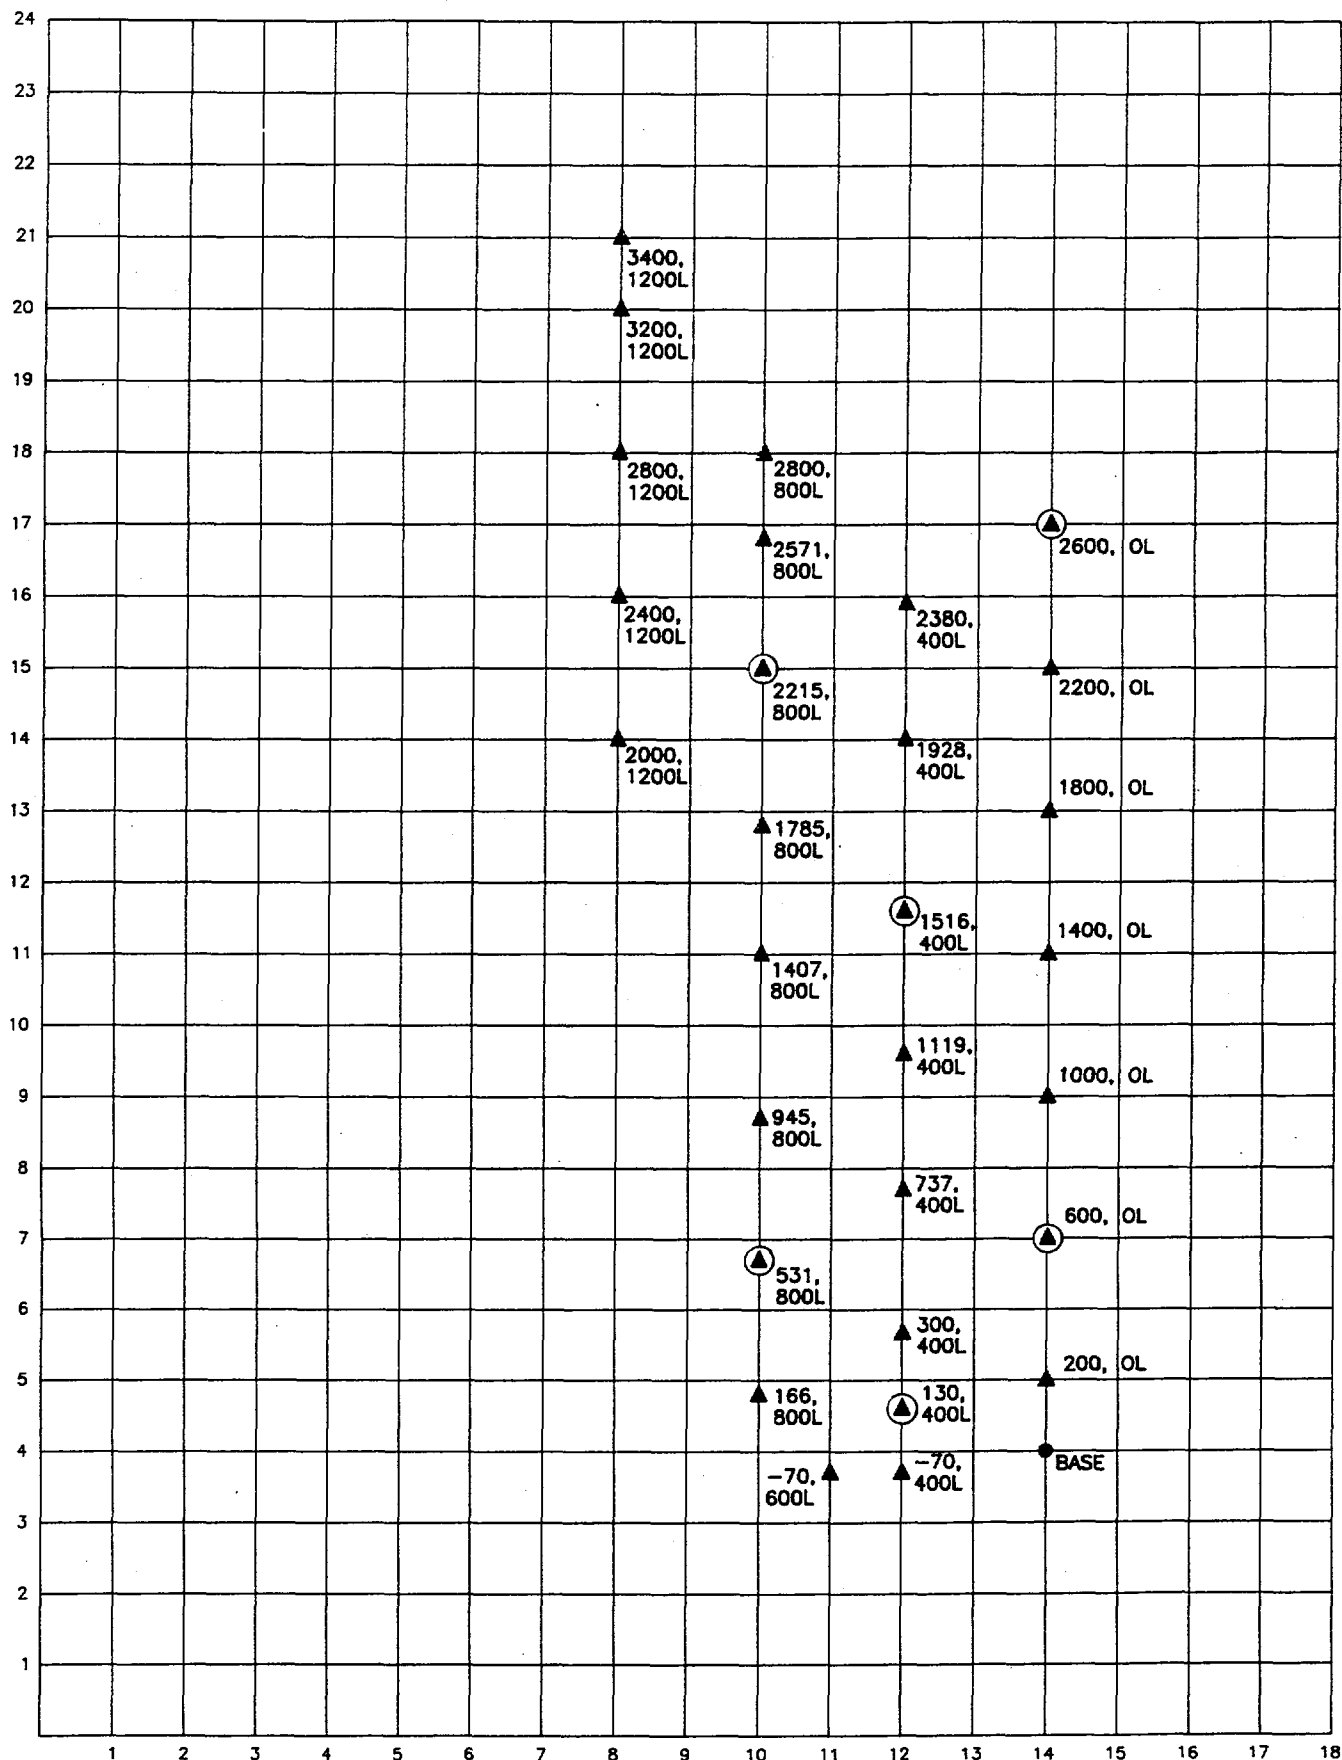
Depth of cover was determined at 29 locations over the tailings area. These locations are depicted on Figure 2. Locations were determined by first establishing a reference line in an approximate direction of northwest to southeast through the tailings area (Figure 1). This reference line includes and is a continuation of a straight portion of the tailings containment structure as shown in Figure 1. Points were marked along this reference line at 200 or 400 foot intervals. At 2800 feet from the base point a second reference line was established in a perpendicular direction to the first reference line. This second reference line extended in an approximate direction from southwest to northeast. For the purpose of sampling or soil cover measurements, all locations within the tailings area were identified relative to these two reference lines. For example, a sample location identified as 1900, 800L would be 1900 feet from the base point (using the first reference line) and 800 feet to the left (northeast) using the second reference line.

The grid pattern shown in Figure 2 represent much of the entire tailings area. Of the 29 points on this grid only 1 point had no cover soil and no salt grass present. Nine of the 29 points (approximately 30 percent) had no cover soil present. At the 20 points where cover soil was present, the cover soil was 6 inches thick or less at 6 points and greater than 6 inches in thickness at 14 points.

Figure 2 shows the location of six soil samples collected on August 6, 1992. Each of these samples, except sample RF-SO-3, was taken from soil that was added by UPCM as cover to the site. Table 2 contains analytical results for these samples and the normal ranges for these elements in soils of the western United States. Sample RF-SO-3 was collected within an area covered by salt grass. As discussed, where salt grass is currently established soil cover has not been added by UPCM. This soil sample is more likely to be representative of tailings material.
